Manhole Inspection Summary

Manhole # S43A2_007MH

Insp Date: **12/19/07 10:33 AM**

Location Address: **1301 Cambria St**

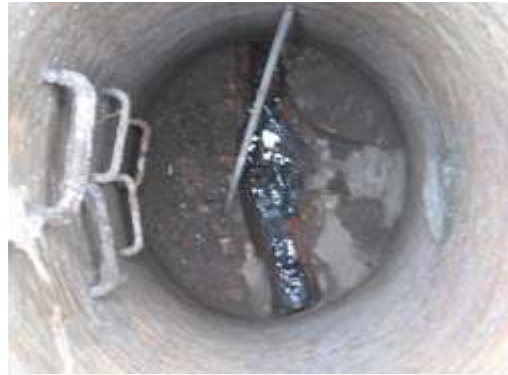
Top View

Condition: ☐ Sound ☐ Cracked ☐ Root Intrusion ☒ **Loose Brick** ☐ Deteriorated

Infiltration: ☐ None ☒ **Joint** ☐ Cracks ☒ **Mortar** ☐ Roots ☐ Wall
